**EXPERIMENTAL TESTING  
OF THE PIKOTEK 6" 1500#  
HP VCS FLANGE GASKET**

**Prepared for  
PIKOTEK  
Lakewood, Colorado**

**December 1997**

**STRESS ENGINEERING SERVICES, INC.**  
Houston, Texas

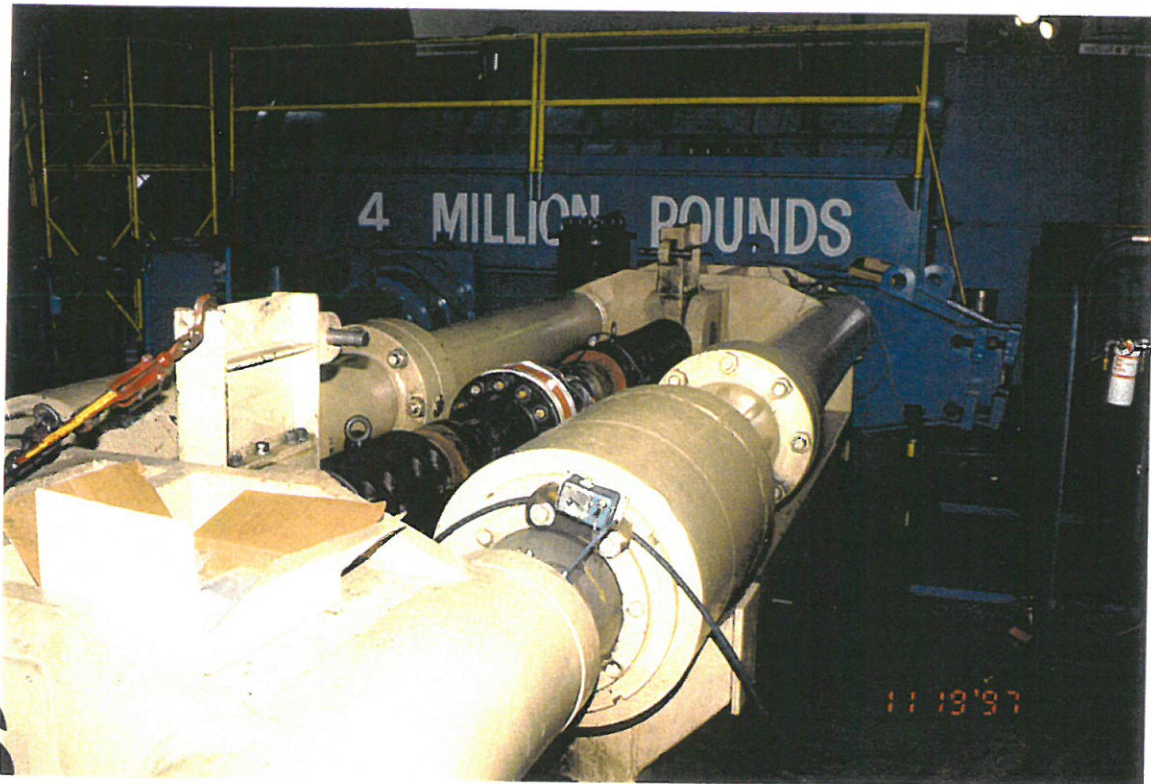
**Figure 6** Photograph of the flange assembly installed in the load frame

Once the make-up process was complete, the flange assembly was placed in the SES 2.5 million lb. load frame. This load frame is capable of generating 2.5 million pounds in tension, 1 million in compression, and 100,000 ft-lbs. in bending. **Figure 6** provides a photograph of flange assembly installed in the load frame. For the purposes of this testing, the sample was pressurized (for the hydrostatic and nitrogen cycle testing) and the load frame served only as a cradle; however, in the bending phase of the testing the load frame placed a bending moment of 50,000 ft-lbs. on the sample using a combination of hydraulic cylinders (the top one acting in compression and the bottom one acting in tension).

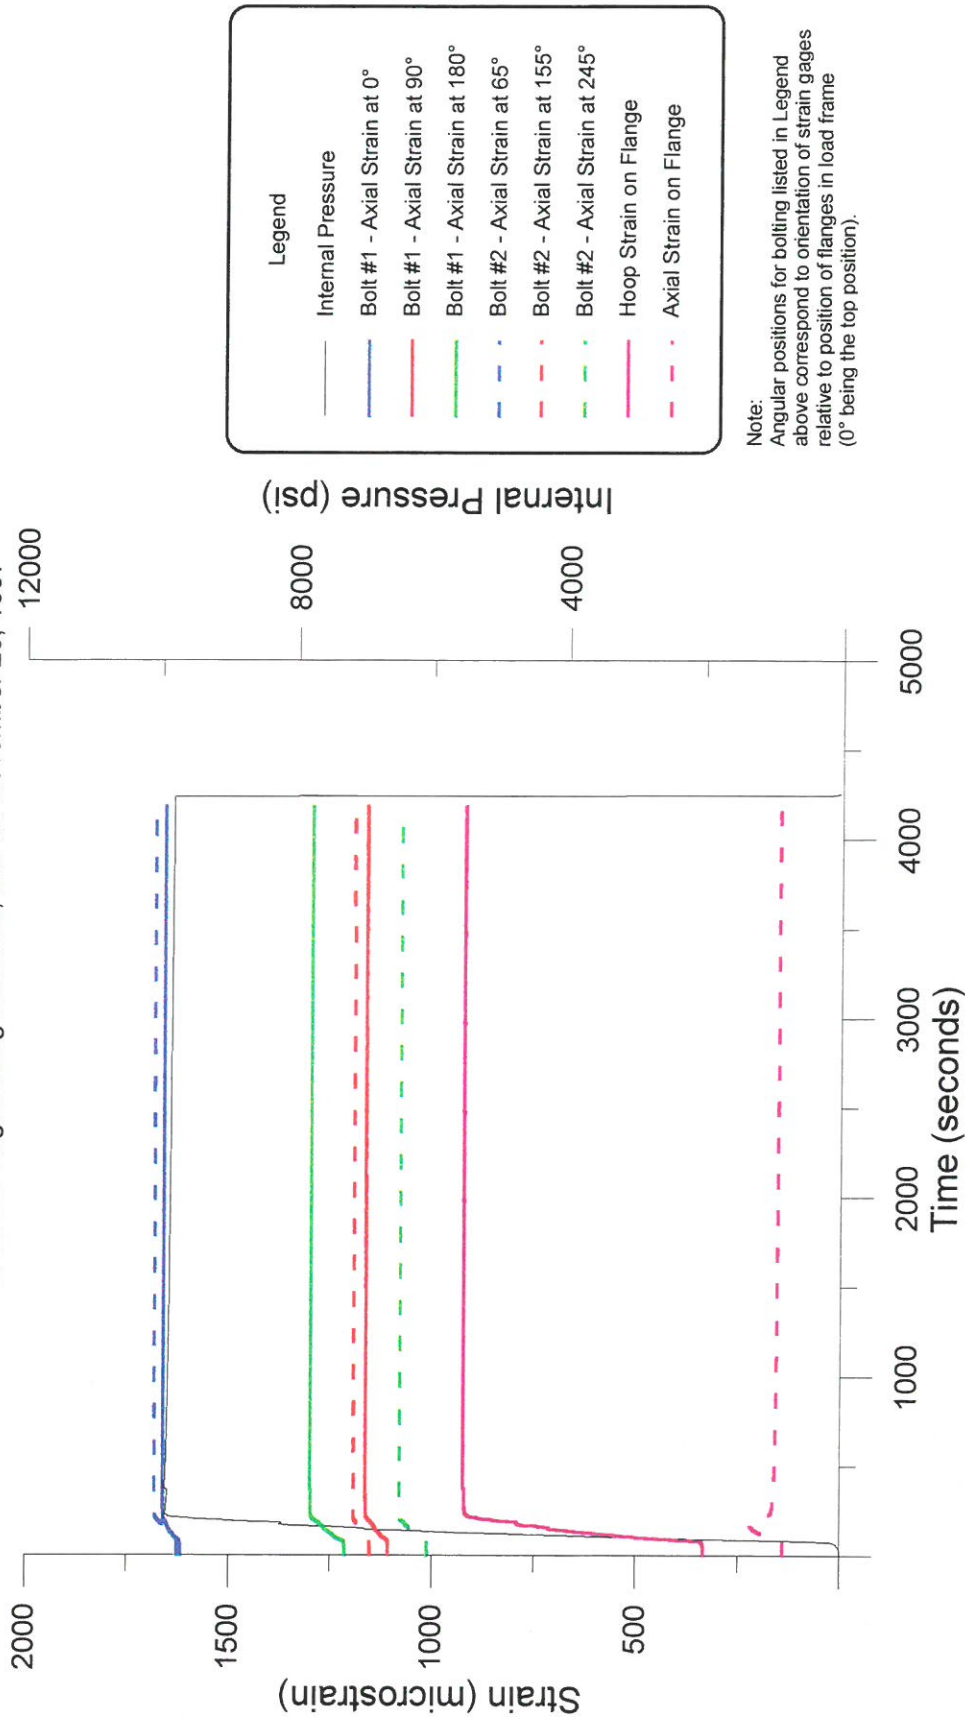
# Figure D1 STRAIN AND PRESSURE AS A FUNCTION OF TIME HYDROSTATIC TESTING TO 9,900 psi

There are several noteworthy observations in relation to the data provided in **Figure D1** of **Appendix D**.

- During the 60-minute pressure hold, there was a drop in pressure from 9,924 psi to 9,834 psi, which was less than the 500 psi drop permitted by the Pikotek Testing Procedure.
- Once the desired internal pressure was established, there was no change in the bolt strain as indicated by the measurements for Bolt #1 and Bolt #2.

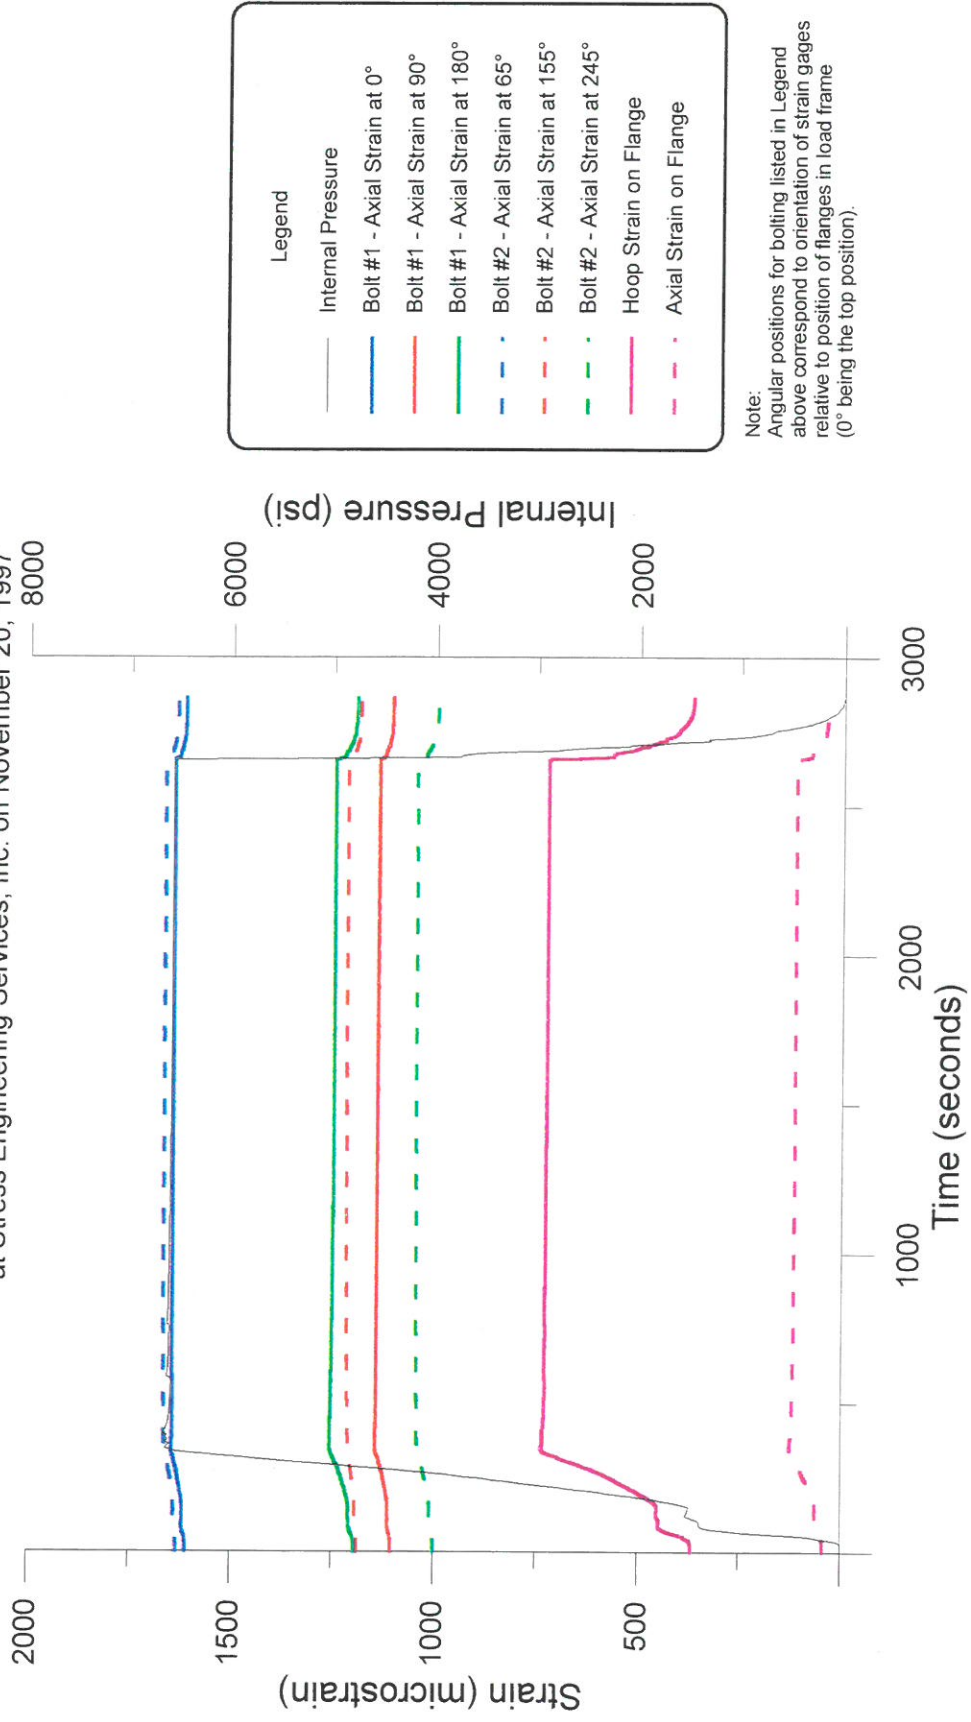
# Figure E1 STRAIN AND PRESSURE AS A FUNCTION OF TIME NITROGEN TESTING TO 6,600 psi (CYCLE #1)

**Appendix E** contains the plots showing strain in the bolting and flange as a function of cycle time for the nitrogen cycle testing (**Figure E1** through **E10**). There are two main observations that are made in observing these plots,

- In the course of conducting the nitrogen testing, there is minimal change in the strain readings for the various members when comparing results between the cycles. This is

important because it shows the consistent behavior exhibited by the flange and gasket in the presence of cyclic loading.

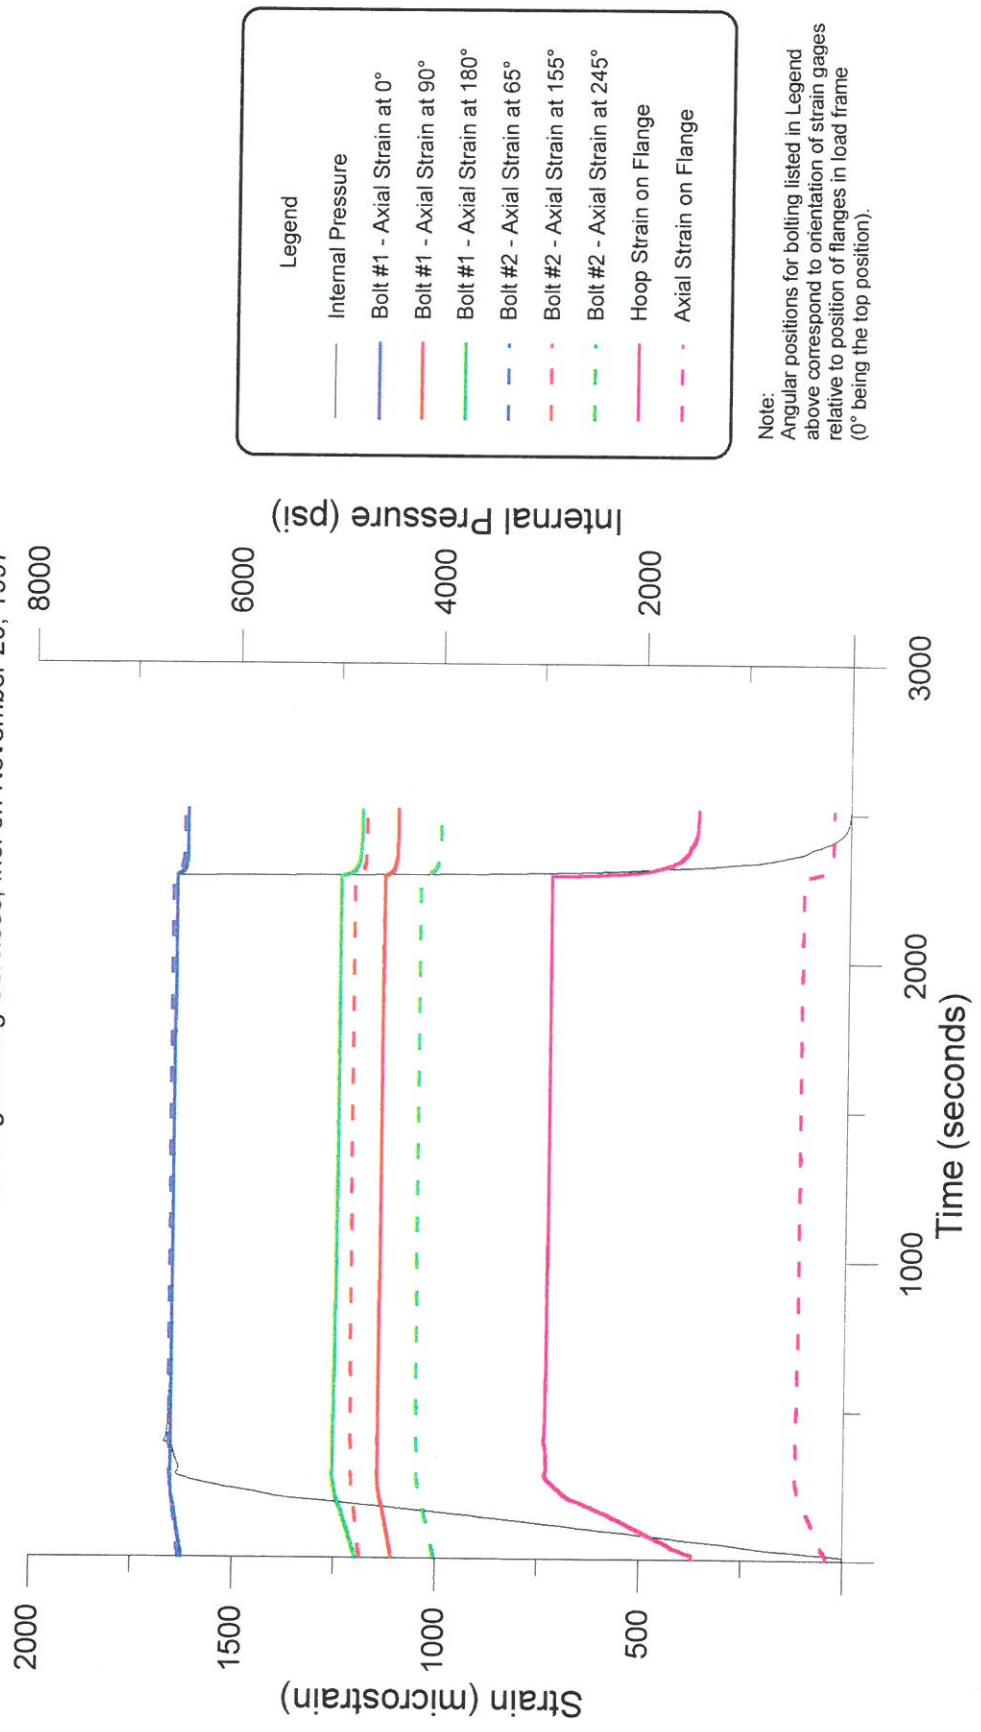
# Figure E8 STRAIN AND PRESSURE AS A FUNCTION OF TIME NITROGEN TESTING TO 6,600 psi (CYCLE #8)

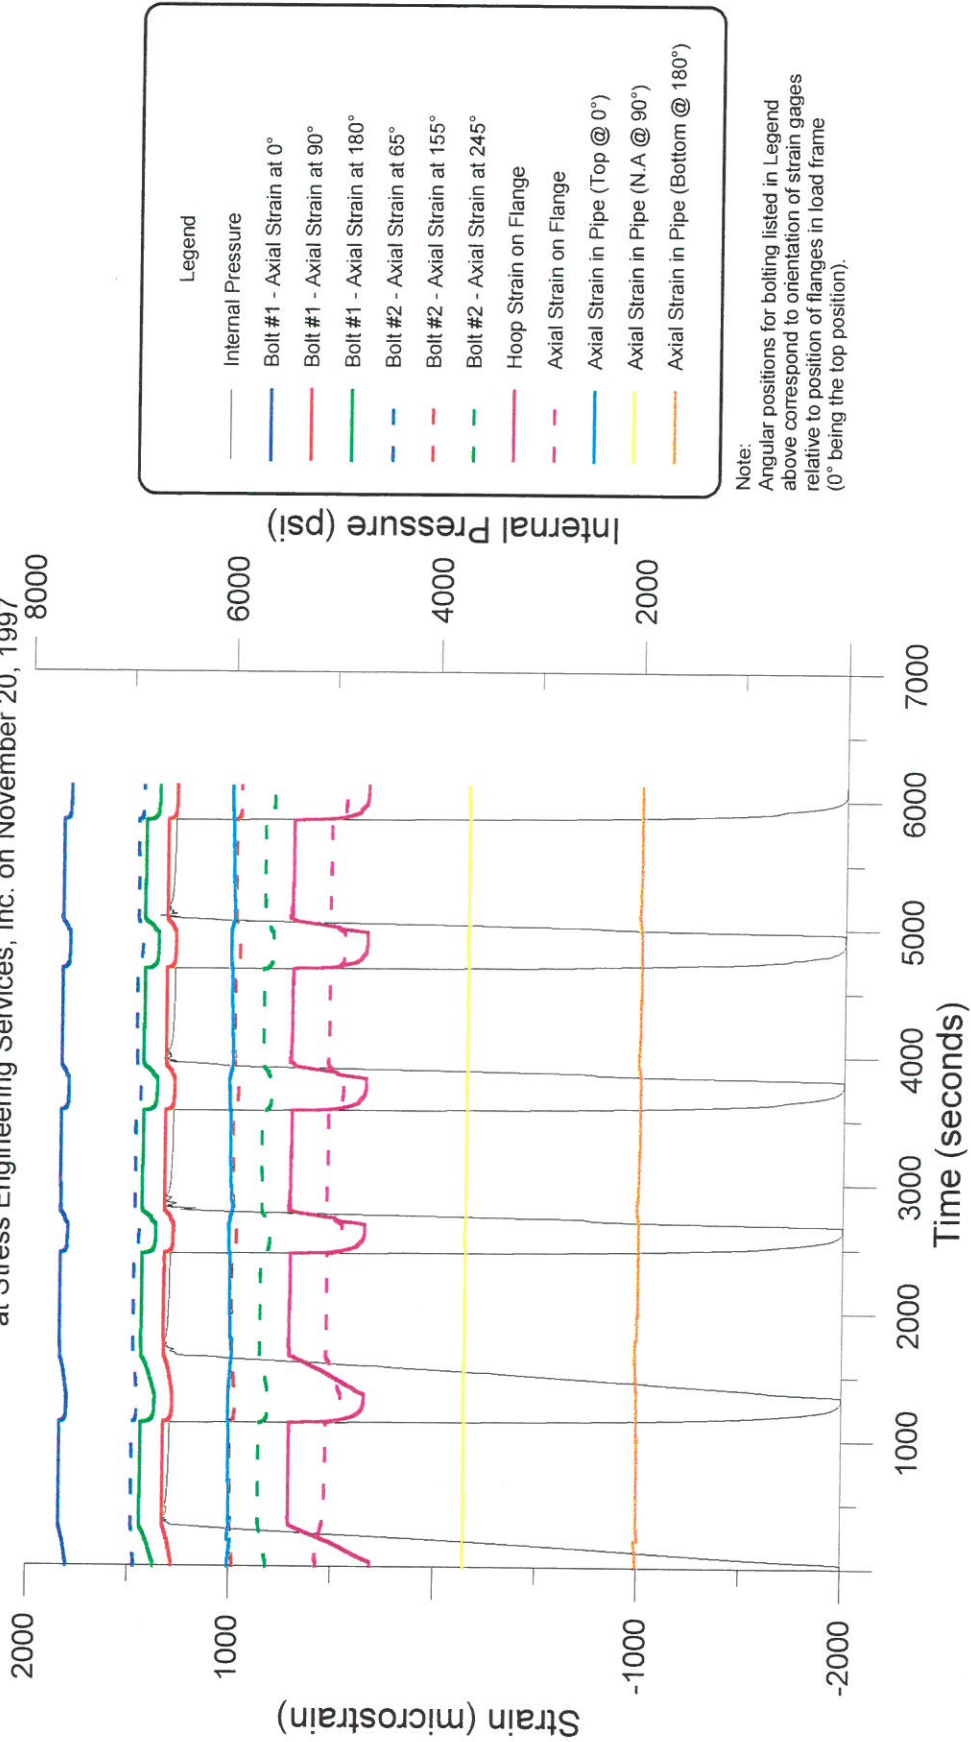
# Figure F1 STRAIN AND PRESSURE AS A FUNCTION OF TIME BENDING TO 50,000 FT-LBS. AND NITROGEN TESTING TO 6,600 psi (CYCLES #1 - #5)

- The strains in the bolting change as a direct result of the bending process, as would be expected. In studying the axial strain readings for the bolts at 0 and 180°, the strain in the top bolt is increased while the strain in the bolt at 180° is decreased. Consider the following changes in strain data between the make-up condition and the flange assembly subjected to 50,000 ft-lbs.,

- The primary objective in subjecting the flange assembly to 50,000 ft-lbs. was to determine if under these conditions the gasket would seal the flanges. During testing, no leakage was detected considering either the bubble leakage system or decreases in internal pressure.
